Investigation of Failure Mechanism of a DCI Engine Connecting Rod

In reciprocating engines, connecting rod cap and connecting bolts are critical as they are exposed to varying loads under different operating conditions. This paper focuses on the failure of the connecting rod of a 1.5 dci K9K diesel engine. As a result of the engine operating for approximately 378400 km, the connecting rod was broken, and the reasons for the failure of the connecting rod cap and connecting bolt were investigated. The connecting rod of the K9K engine was designed in accordance with the dimensions by using SolidWorks software, and then exported to ANSYS software for stress and fatigue analysis. Also, the macrostructure of the broken connecting rod cap and bolt was investigated. We knew that the mechanic who fixed the engine about two years ago tightened the connecting rod bolts without using a torque meter. Therefore, stress and fatigue analyses were performed to determine the effect of different tightening torques (ranging from 22.5 to 52.5 Nm) at 2000 rpm. According to the numerical analysis results, with increasing tightening torque, the maximum equivalent stress and alternating stress values incr

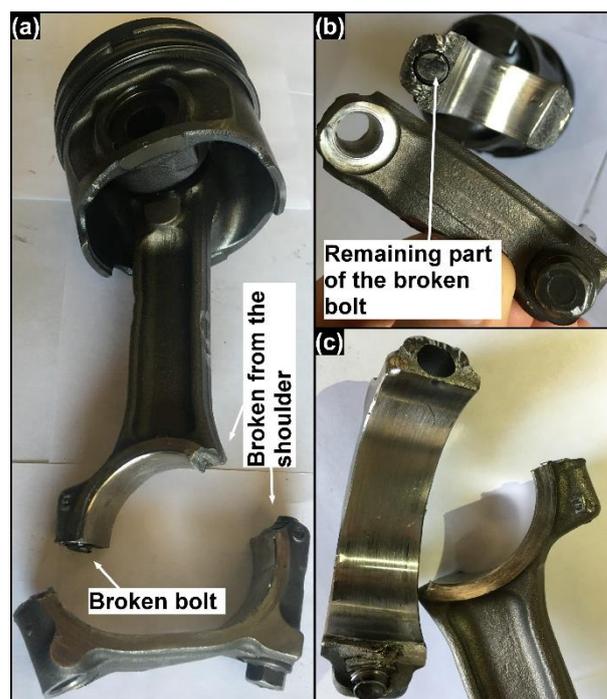
Figure 1. Macro view of the connecting rod after failure. (a) general view, (b) and (c) broken parts.

When the engine was disassembled, one of the connecting rods was found to be broken. The vehicle was known to be at 378400 km when the failure occurred. Also, about 2 years ago from the connecting rod failure, the crankshaft was changed for another reason, and therefore the connecting rods were removed and reassembled. However, it was learned that the mechanic did not use a torque meter during this removal and reassembly of the connecting rods. The connecting rod was removed, and as seen in Figure 1 (a), in the big end region, the left bolt connecting the lower cap and the upper cup of the connecting rod was broken in the middle. The remaining part of bolt on the connecting rod shank could be seen in Figure 1 (b). The bolt on the right was intact (Figure 1 (a and c)). However, the right side of the connecting rod was broken from the big end shoulder. Also the lower cap of the big end was deformed.

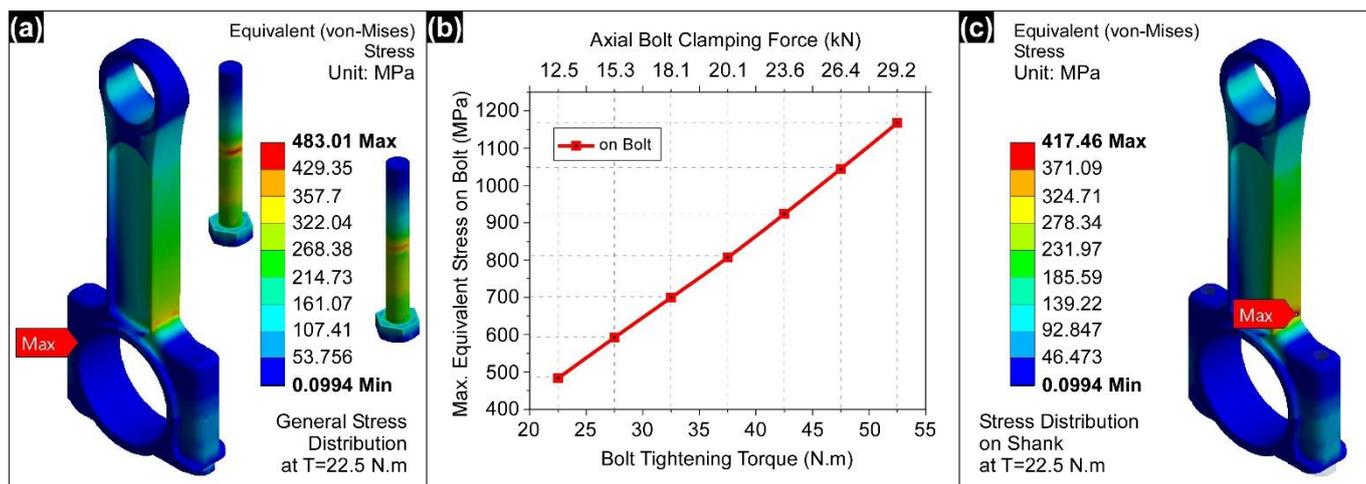
Figure 3. (a) equivalent (von-Mises) stress distributions on the all components of connecting rod, (b) graph of max. equivalent stress values on the bolt as a function of bolt tightening torque, (c) equivalent stress distributions on the connecting rod shank.

As a result of nonlinear static analyzes performed with the application of different bolt pretensions, maximum equivalent stress values in the connecting rods were obtained (Table II). During the analyses, bolt pre-tensions caused by different tightening torques varying in between 22.5 - 52.5 Nm were applied to the connecting rod. As seen in Figure 3 (a), the zone of maximum equivalent stress (483.01 MPa) at normal bolt tightening torque (22.5 Nm) was observed at the left-side bolt. This zone corresponded to the junction of the lower and upper cup of the connecting rod. In fact, as seen in Figure 1, the bolt on the left-side was broken at this zone. This equivalent stress value was considerably lower than the yield strength value of the bolt (1540 MPa). Therefore, at normal tightening torque, the stress safety factor in this zone was about "3.2" and it did not pose any problem. However, as seen in Figure 3 (b), the maximum stress value in this region significantly increased with the increase of the tightening torque. Such that, at the 52.5 Nm tightening torque, the maximum equivalent stress value on the bolt was 1167.5 MPa. This meant that the stress safety factor was approximately "1.3".

Witek et al. [24] stated that connecting rod bolts were subjected to complex loads acting as both tension and compression during engine operation. Therefore, the risk of breaking of the connecting rod bolts was high when the bolts were tightened above the normal tightening torque. On the other hand, as seen in Figure 3 (c), the maximum stresses on the connecting rod shank were concentrated in the right shoulder zone (417.46 MPa). This zone (right shoulder region of the connecting rod) was also the region where the break in the connecting rod shank occurred (see Figure 1). Because the maximum in cylinder pressure occurred when the crank angle was 10° after the piston top dead center, the load was applied to the piston pin of the connecting rod at an angle of 3.55 degrees. Therefore, the zones where the stresses concentrated on the components of connecting rod and the zones where the fractures occurred were completely matched.

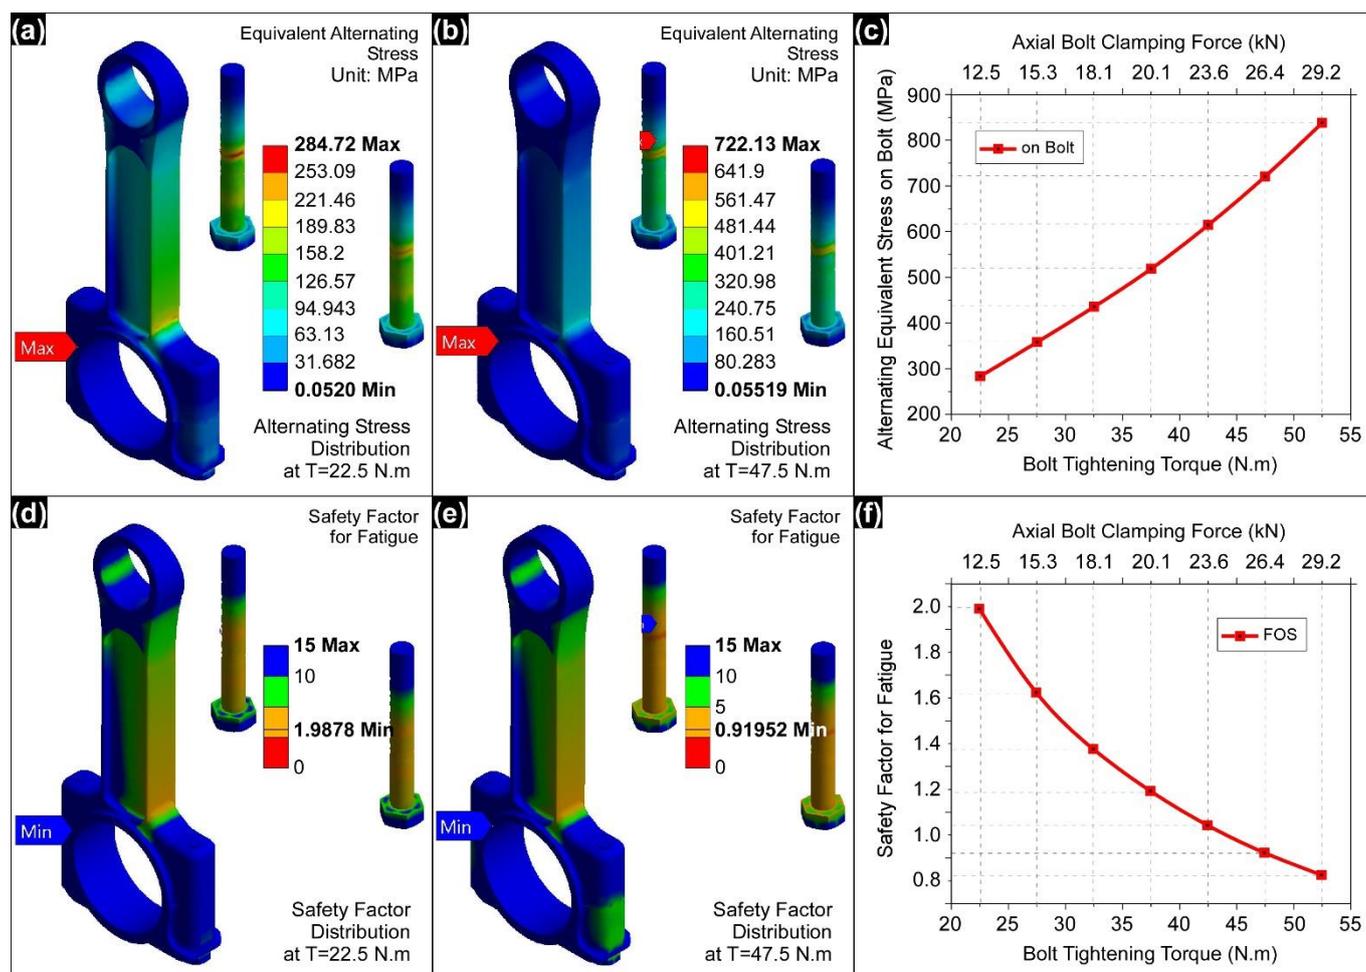
Figure 4. (a) Distribution of equivalent alternating stress at $T=22.5$ Nm, (b) distribution of equivalent alternating stress at $T=47.5$ Nm, (c) graph of alternating stress vs bolt tightening torque, (d) distribution of safety factor for fatigue at $T=22.5$ Nm, (e) distribution of safety factor for fatigue at $T=47.5$ Nm and (f) graph of safety factor for fatigue vs bolt tightening torque.

-0.046 was used for the stress-life fatigue analysis. As expected, equivalent alternating stresses were concentrated on the bolt where equivalent stresses were maximum (see Figure 1 (a and b)). The maximum value of equivalent alternating stress considerably increased with increasing bolt tightening torque. While the maximum value of equivalent alternative stress was 284.72 MPa at normal bolt tightening torque (22.5 Nm), this value increased to 839.37 MPa at 52.5 Nm bolt tightening torque (Figure 1 (a-c)). Tabulated data including all the results of the fatigue analysis are given in Table II. Tabulated data including all the results of the fatigue analysis were given in Table II. On the other hand, as seen in Figure 4 (d-f), safety factor values for fatigue decreased with the increasing bolt tightening torque. At normal bolt tightening torque, safety factor for fatigue was about "1.99" (Figure 4 (d and f)). This value was quite satisfactory in terms of fatigue. However, this value was lower than "1", especially with the application of 47.5 Nm and higher bolt tightening torque (Figure 4 (e and f)). This greatly increases the likelihood of fatigue damage. As Consistent with this, as seen in Table II, at 42.5, 47.5 and 52.5 Nm bolt tightening torque values, the fatigue life of connecting rod decreased to 3.45×10^9 , 6.81×10^7 and 2.25×10^6 cycles, respectively. As explained in the previous section, the zones where alternating stresses and minimum safety factors

concentrated were the points where breakage occurred in the connecting rod (left bolt and right shoulder).

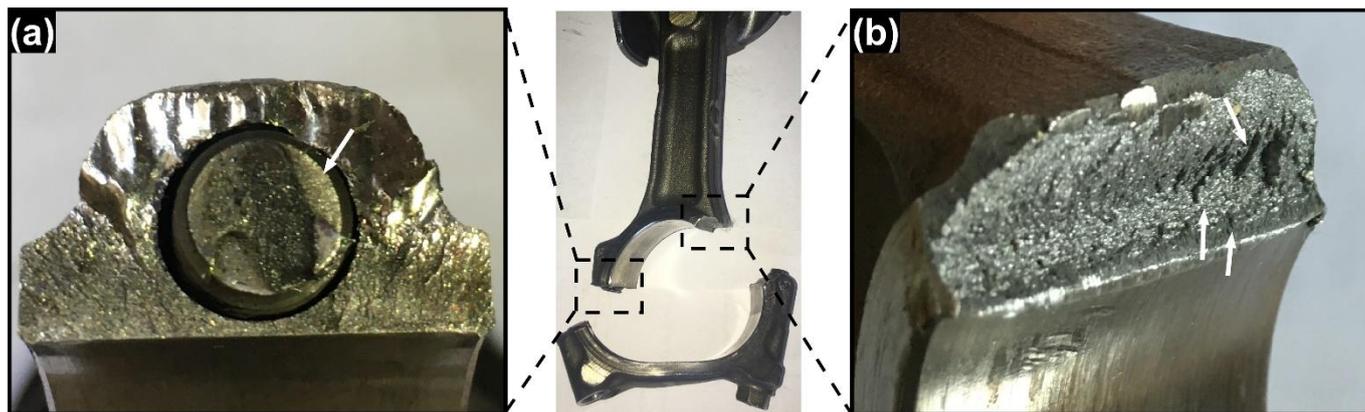
Figure 5. Macrostructure of damaged zones. (a) fracture surface of the remaining part of the broken left side bolt and (b) fracture surface of the broken right side shoulder.

The macrostructural photograph of the damaged zones of the connecting rod was given in Figure 5 (a and b). In Figure 5 (a), the possible fatigue area in the remaining part of the broken bolt is indicated by the arrow. Due to the fact that the mechanic did not use a torque meter, fatigue occurred in the over-tightened bolt, and the remaining section of the bolt after the fatigue damage area was broken because it could not bear the axial clamping force. As proved in the previous sections, the stresses in the broken region of the bolt were maximum and the safety factors were minimum. Immediately after the bolt on the left broke, the right shoulder area of the connecting rod was overloaded (stresses were also concentrated in this area as the maximum cylinder pressure took place at the crank angle of 10° ATDC). The deformed lower cap hit the cylinder liner and broke on the right shoulder and completely separated from the connecting rod shank. As a result, a brittle fracture occurred in the right shoulder region (Figure 5 (b)). As evidence of this, chevron markings (indicated by arrows in Figure 5 (b)) were observed in the fracture zone. Because it was reported that chevron markings typically result from the brittle fracture of steel materials [32]. Then the rings and valves took damage due to the uncontrolled movement of the piston. Thus, the connecting rod bolt, which had fatigue fracture due to excessive tightening torque, caused the connecting rod to break completely and the engine to be seriously damaged.

The present work was aimed to determine failure mechanism of a K9K diesel engine connecting rod. Existing connecting rod was broken from right side bolt and left side shoulder (on shank). We knew that the mechanic who fixed the engine about two years ago tightened the connecting rod bolts without using a torque meter. Therefore, stress and fatigue analyzes were performed to determine the effect of different tightening torques (ranging from 22.5 to 52.5 Nm) at 2000 rpm. The maximum equivalent stress and alternating stress values increased from 483.01 to 1167.5 MPa and 284.72 to 839.37 MPa, respectively. After a tightening torque of 42.5 Nm, the fatigue safety factor was lower than "1", and cycling life decreased up to 2.25×10^6 cycles. The points where the failure in the connecting rod occurred and the zones where the stresses concentrated in the analyzes were compatible. Firstly, a fatigue

fracture occurred in the right hand bolt. Immediately after, the lower cup deformed and crashed to the cylinder liner. Therefore, a brittle fracture occurred on the left shoulder of the connecting rod shank. The chevron markings were clearly visible in the macrostructure as evidence of brittle fracture. As a result, the use of torque meters was very important in the assembly of engine post-repair parts.
