Investigation of Failure Mechanism of a DCI Engine Connecting Rod

In reciprocating engines, connecting rod cap and connecting bolts are critical as they are exposed to varying loads under different operating conditions. This paper focuses on the failure of the connecting rod of a 1.5 dci K9K diesel engine. As a result of the engine operating for approximately 378400 km, the connecting rod was broken, and the reasons for the failure of the connecting rod cap and connecting bolt were investigated. The connecting rod of the K9K engine was designed in accordance with the dimensions by using SolidWorks software, and then exported to ANSYS software for stress and fatigue analysis. Also, the macrostructure of the broken connecting rod cap and bolt was investigated. We knew that the mechanic who fixed the engine about two years ago tightened the connecting rod bolts without using a torque meter. Therefore, stress and fatigue analyses were performed to determine the effect of different tightening torques (ranging from 22.5 to 52.5 Nm) at 2000 rpm. According to the numerical analysis results, with increasing tightening torque, the maximum equivalent stress and alternating stress values incr

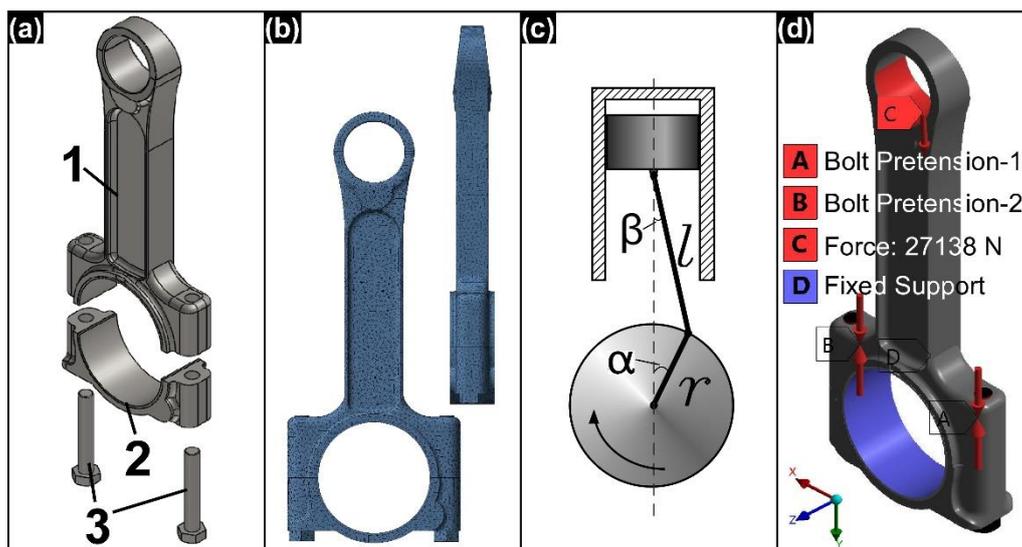
Figure 2. (a) Main parts of connecting rod, (b) finite element model showing meshes, (c) angles of crankshaft and connecting rod at the maximum in cylinder pressure, (d) loading conditions.

To understand the mechanism of connecting rod failure, first, the geometric model of the connecting rod was created using SolidWorks software. As seen in Figure 2 (a), the connecting rod consisted of three basic components. Part 1, 2 and 3 were the connecting rod shank, lower cap and bolts, respectively. Then, the created model was exported to the ANSYS Workbench software for numerical analysis. AISI 4140 low alloy steel was defined as the material with linear-elastic properties [13]. The maximum young's modulus, yield strength, ultimate strength and poisson ratio of 4140 steel were 210 GPa, 1540 MPa, 2073 MPa and 0.29 %, respectively. In the next step the contact definitions between neighboring components were carried out. The friction coefficients of bolts and all other parts were defined as 0.15 and 0.1 μ , respectively [24]. Tetrahedron meshes were used to divide the connecting rod into finite elements (Figure 2 (b)). The average mesh quality value was tried to be 0.85 and above to obtain more accurate results. To achieve this, different operations such as patch independent, patch conforming and mesh sizing were applied. The model was occurred with 160994 nodes and 104508 elements.

Here, M was mass of piston and rings + Piston pin + 1/3 rd of the connecting rod. ω , r and l were angular speed (rad/s), crank radius (mm) and length of the connecting rod (mm), respectively. α was crank angle ($^\circ$). Moreover, different bolt pressures were applied to the bolts as seen in Figure 2 (d). The required normal bolt tightening torque value was obtained from the K9K engine workshop repair manual (Renault Technical note) [30]. This value was $20 \pm 2 \text{ Nm} + 45^\circ \pm 6^\circ$, and it converted to the clamping force (N) value by using simply Equation 5.
